# DECISION PAPER

Make repairs per inspections for compliance, replace expired VGB Drain covers, and implement overdue pool repairs at each body of water located at Trout Creek Recreation Pool, Kiddy Pool and Covered Spa.

### TROUT CREEK REC CENTER - RECREATION POOL - E

**TROUT CREEK REC CENTER – COVERED SPA - F**

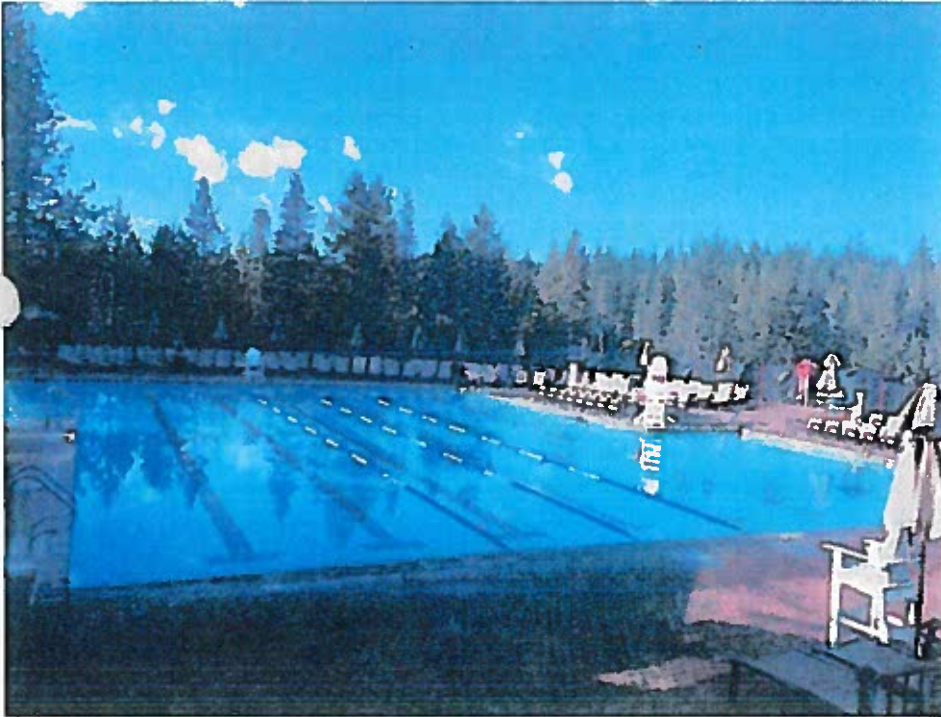
**Spalled concrete at handrails**

**Blue Tiles that have been replaced due to the old tiles failing and falling out**

Skimmers – various photos of cracked and spalled concrete

Deck Marker missing

1. Permit from County Environmental Health Department
2. Drain pool to approved cleanout and drill relief holes
3. Strip existing plaster back to original gunite shell and haul away debris

4. Saw cut concrete decking, remove and replace existing skimmers – 12 total
5. Install commercial nonskid trim tile at entry steps and bench per code
6. Install new commercial nonskid tile at racing lanes and targets 2x2 black

7. Remove and replace existing waterline tile with new 6x6 tile per code
8. Remove and replace existing coping with new safety grip precast coping. Includes mastic expansion joint between new coping and existing concrete decking

11. Remove and replace existing pool lights with new commercial white LED white lights
12. Supply and install new commercial 3 bend entry rails at pool shallow end entry steps per code – 5 total

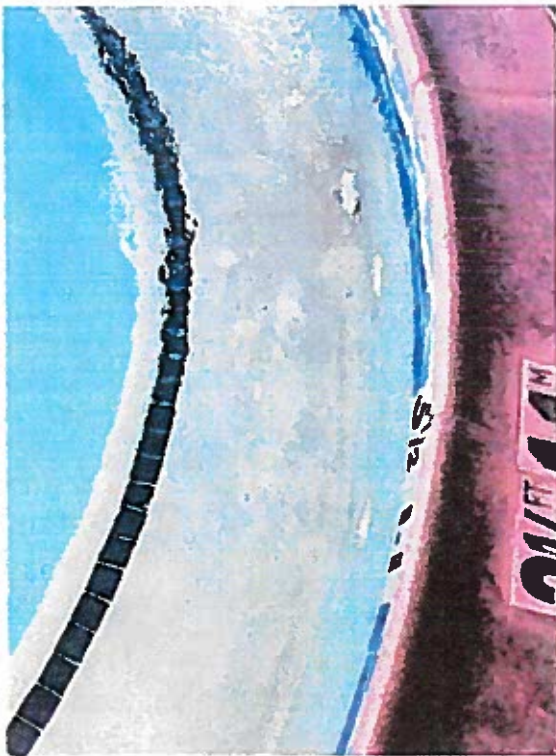
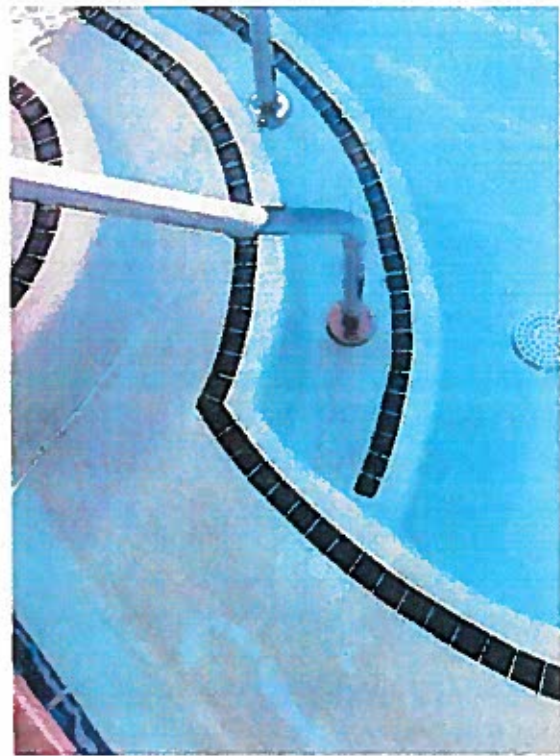
Staining & pitting of Plaster

13. Remove and replace existing spa lights with new commercial white LED white lights – 2 total
14. Plaster spa with 2 coats of premium 100% white quartz finish, comes with a 5-year warranty

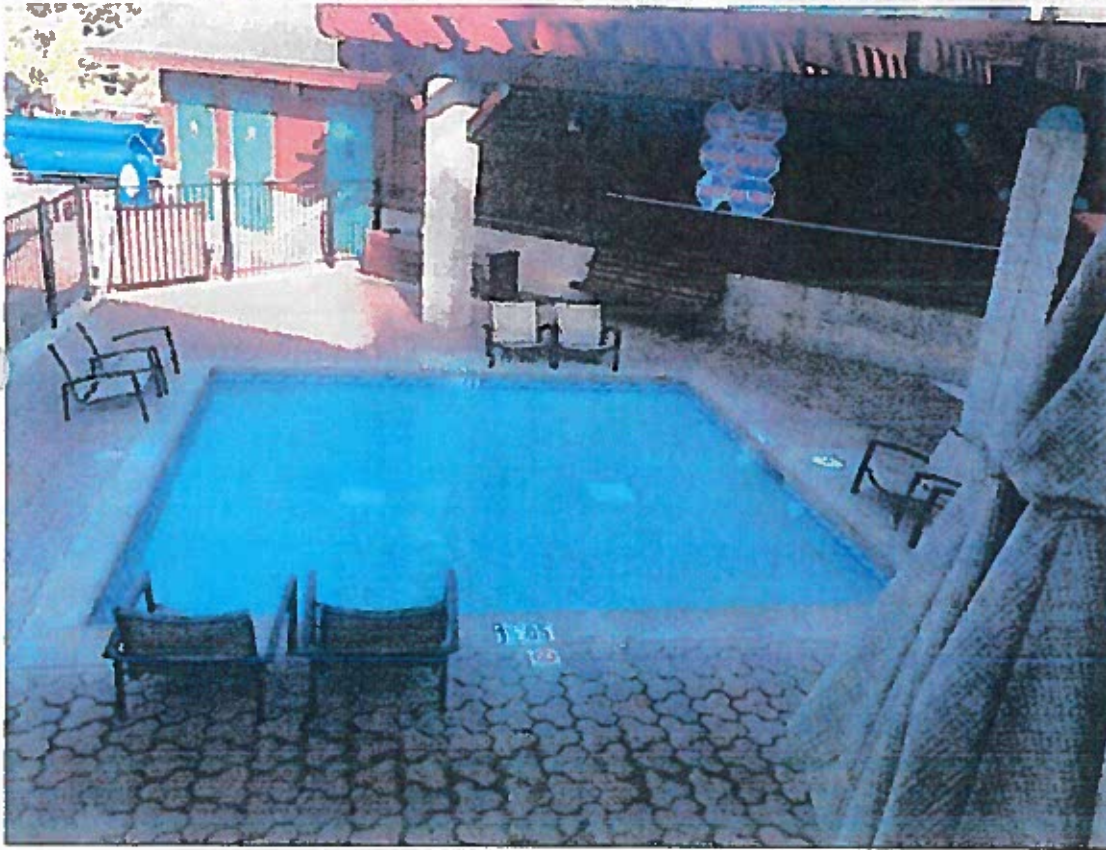
**TROUT CREEK REC CENTER - KIDDY POOL - G**

## Staining & pitting of Plaster

## Skimmer – Concrete spalling

1. Permit from County Environmental Health Department
2. Drain pool to approved cleanout and drill relief holes
3. Strip existing plaster back to original gunite shell and haul away debris

4. Saw cut concrete decking, remove and replace existing skimmer
5. Saw cut wall at existing skimmer equalizer lines and move existing line to floor per code.

6. Remove and replace existing waterline tile with new 6x6 tile per code
7. Remove and replace existing coping with new safety grip precast coping. Includes mastic expansion joint between new coping and existing concrete decking
