Euer Valley
Restoration —
Phase 1
30% Design
Update to Tahoe
Donner Board

Eben Swain Feb. 26, 2020

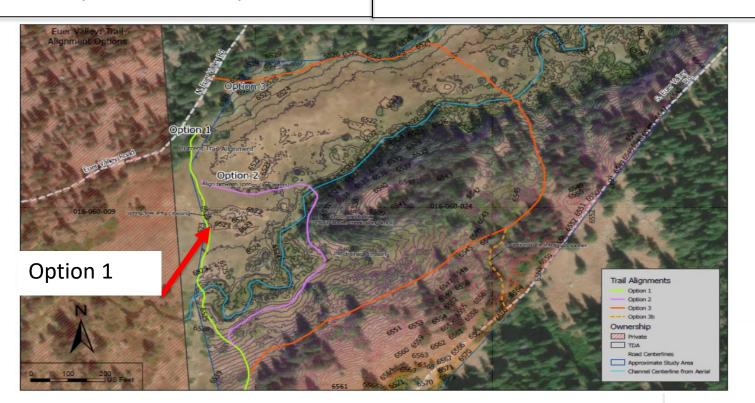
1. West Trail Alignment (Existing)

- Encompasses area of existing use.
- Has the least amount of new disturbance.
- Minimal to zero tree removal.
- Does not disrupt current winter operations

- Traverses a major spring/wetland
- Requires a significant length of boardwalk.
- Bridge crossing located at stream meander

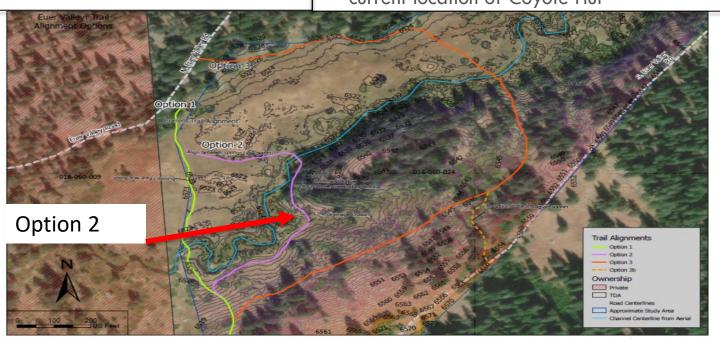
2. East Trail Alignment

- Avoids crossing a major spring/seep
- East bridge abutment could be installed at higher elevation

- Still requires extensive boardwalk construction
- Requires a second drainage/bridge crossing
- Requires tree removal within the "knoll" with potential for cultural sensitivity.
- Creates more new disturbance in wetland habitat
- Disrupts winter trail alignment, grooming operations and current location of Coyote Hut

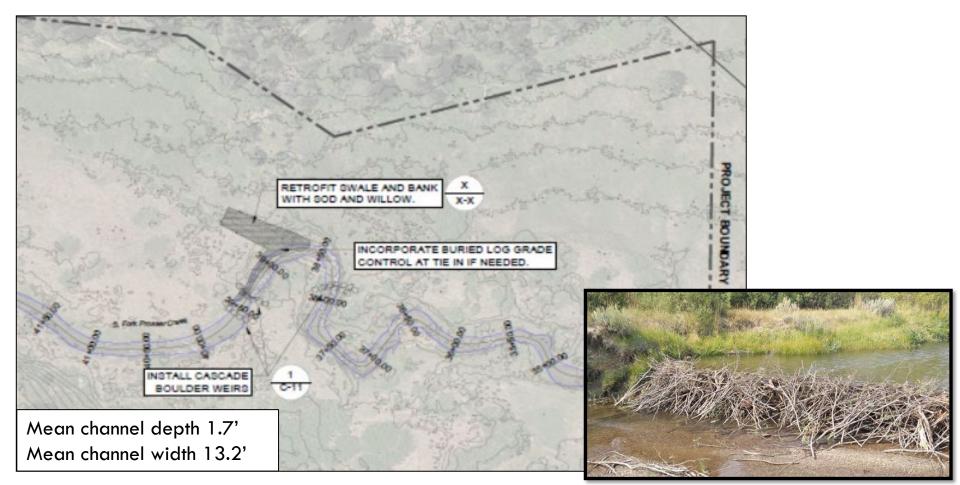
- Boulder step-pools channel stabilization
- Willow Planting stabilization, habitat enhancement
- Root-wad abutments erosion prevention, habitat enhancement
