STAFF REPORT: Marina – Emergency Repair of Structural Roof Columns

BACKGROUND:

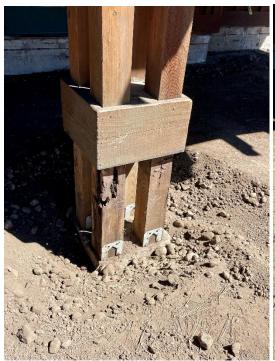
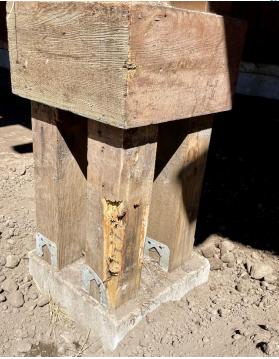
During the demolition of the patio for the Marina Deck Expansion project, GLA Morris Construction discovered that the structural wood columns supporting the building roof overhang extended over two feet below the finished grade/deck, down to concrete foundation piers. It appeared that the wood columns were set in an unvented space under the deck which caused severe decay.

Column bases with rot

Based on the change order pricing received, staff directed GLA Morris Construction to temporarily shore the roof structure and extend the concrete piers, as detailed by the structural engineer, just above the new finished patio height. All structurally compromised posts were replaced. The stone veneer wrap existing on three of the posts was not replaced due to the change in the aesthetic nature with the new paver patio.

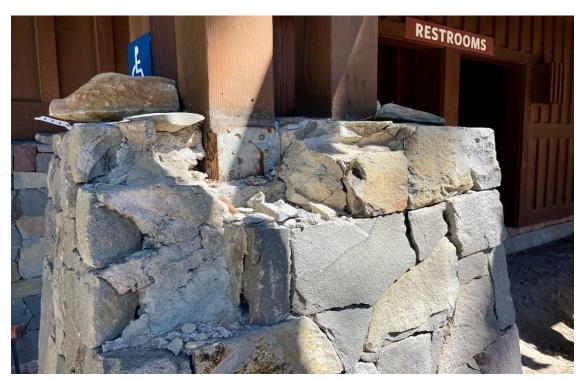
Additionally, three of the columns had a stone veneer wrap that was improperly supported by the Trex decking, causing some of the stones to break loose at the base of the columns. The wood post components of the wrapped columns continued through/inside a portion of the stone veneer and also exhibited signs of decay. The emergency repair of the columns was deemed immediate and necessary due to the decay and structural integrity risk. Staff verbally notified the board of the emergency repair.

Stone veneer column

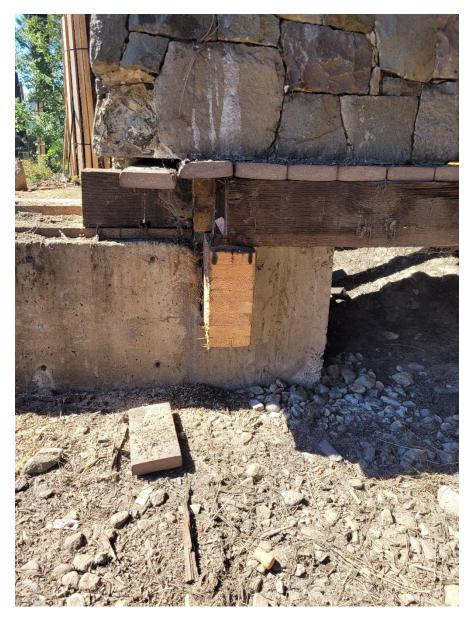
Stone veneer resting on Trex decking
