Euer Valley Restoration Project

30% DRAFT Design Basis Memorandum

Rvsd April 9, 2021

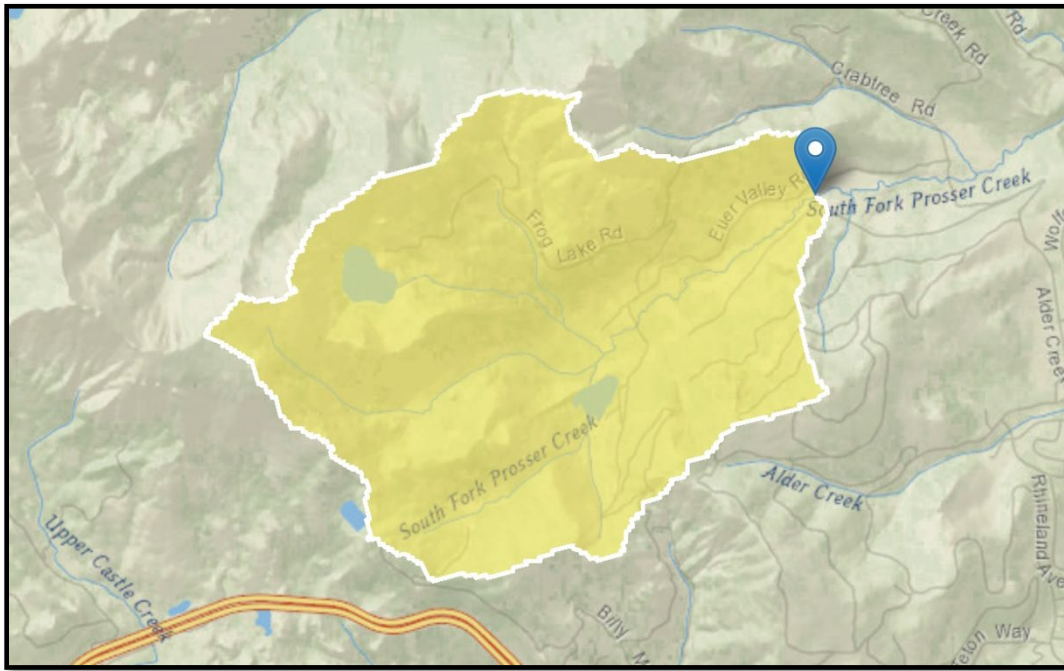
Figure 1. South Fork Prosser Creek Watershed at Project Site *(Source: USGS 2016)*

Euer Valley is located within the Prosser Creek basin, the third largest subwatershed of the Middle Truckee River watershed. South Fork Prosser Creek runs through the Project area (Figure 1) at an elevation just over 6500 feet (ft) and drains an approximate 5.5 square mile watershed before joining Prosser Creek and ultimately draining to the Truckee River. The Truckee River is 303(d) listed as impaired due to suspended sediment. South Fork Prosser Creek and Euer Valley have been subject to historic anthropogenic disturbances including grading, timber harvest, irrigation infrastructure and operation, grazing, railroad, land development and associated road development that likely contributed to channel relocation and aggravated incision and degradation. While the channel has degraded somewhat from anthropogenic disturbances the meadow remains relatively healthy due to the persistent spring and groundwater support with the exception of the localized trail disturbances. Recreation is now the dominant land use within the project area including earthen trails and a culverted crossing at one of the tortuous meander bends (Figure 2). The Project was first identified in the Tahoe Donner Association (TDA) Trails Master Plan due to desired improvements to the Coyote Crossing Trail, which transects the site.

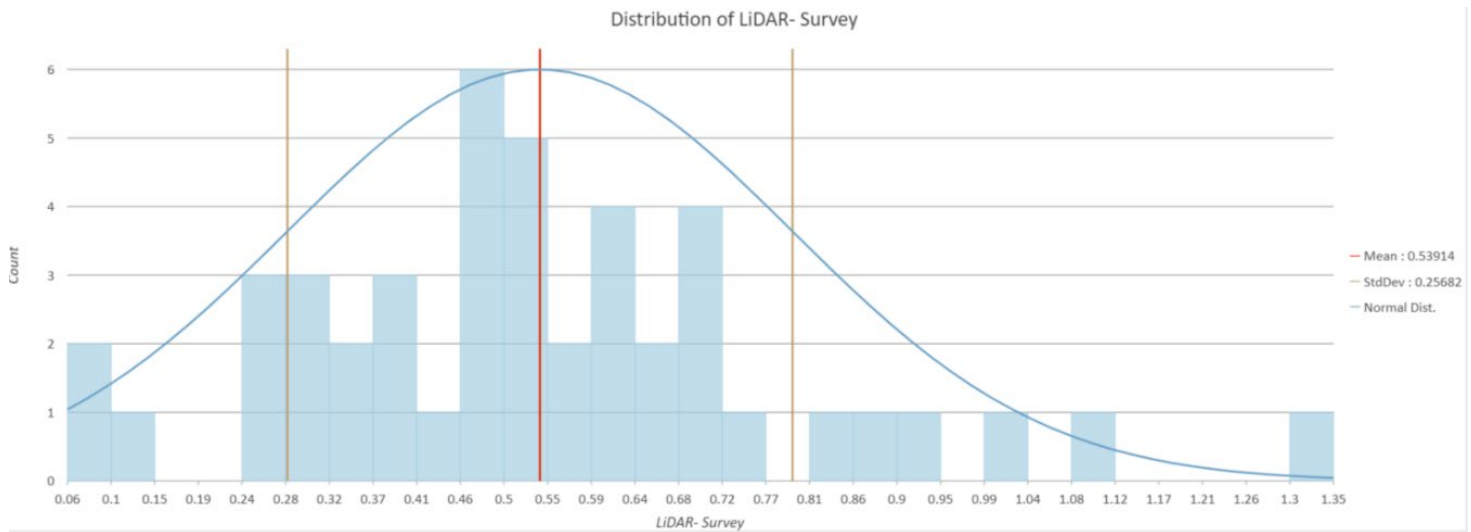
Figure 3. Distribution of the difference between the LiDAR and RTK Field Survey for 45 points collected on the trail.

Differences were observed between the field survey data and the LiDAR data where they overlapped. To determine the cause of these discrepancies Wildscape staff confirmed the field data collected and the OPUS solution for final coordinates, and then compared the field survey topography to the LiDAR topography for areas with no vegetative cover. These areas of bare ground allowed Wildscape to compare survey elevations to LiDAR elevations without the interference of vegetation. Vegetation can cause considerable error in LiDAR data collection since the airborne laser will intercept the vegetation never reaching the ground surface. This is especially true in areas of thick cover such as the meadow grasses encountered at the project site. The technical report for the 2014 USDA Tahoe National Forest LiDAR data was also reviewed and it was learned that the 2014 collection was not compared to field collected survey elevations but was compared to the previous LiDAR collection where the two data collections overlapped, with the resulting reported "accuracy" in the range of 0.16 to 1.15 ft. Given this range, a mean difference of approximately 0.5 ft on trail edge and center (Figure 3) is well within the error of the LiDAR. In summary the LiDAR data is not necessarily more accurate than the field survey data and the differences can be easily rectified by either adjusting the survey data to match the LiDAR data or adjusting the LiDAR data to match the survey data. This adjustment step was not yet taken in order to afford the hydraulic model to be set up early with the LiDAR topographic data set only, however the adjustments can still be made at the next design development stage in order to provide additional informative elevation data.

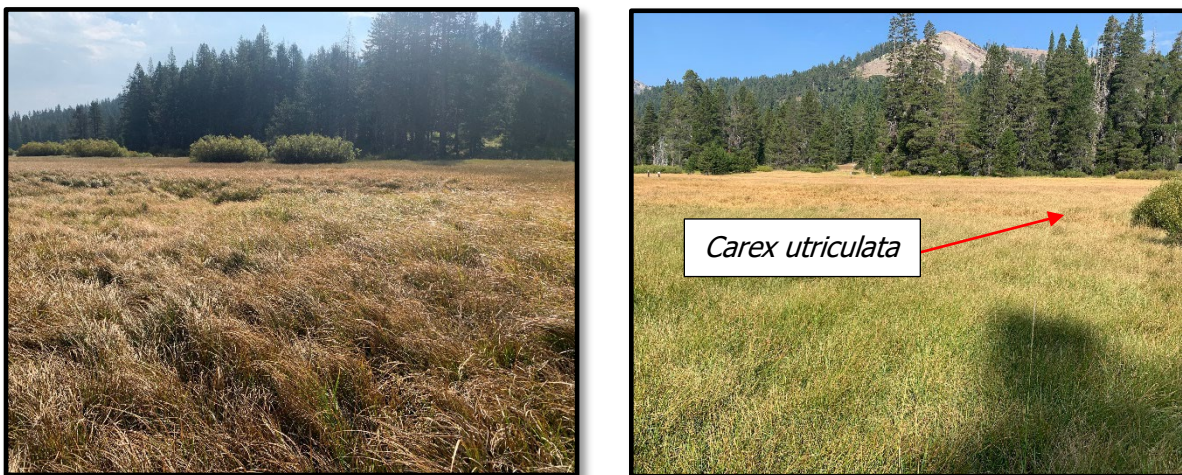
Figure 4. (Left) Monoculture of *Carex utriculata*, (Right). Transition from *Carex utriculata* to *C. nebrascensis* in the foreground.

Julie Etra of Western Botanical Surveys, Inc. (WBS) conducted a plant resource survey to further inform vegetation conditions and provide recommendations on native materials for salvage and reuse as they relate to restoration and erosion control. Due to a late Project start, the plant survey was conducted on August 25, 2020 a suboptimum time for maximum identification of vegetation however adequate for determining dominant plant species and community types. The community types, Wetland, Mesic Meadow/Wetland and Introduced/Transitional were identified and located via GPS (quantification of these community types was not conducted during this survey). Most notable was the almost monoculture of the obligate wetland species, *Carex utriculata* (beaked sedge) between North Euer Valley Road and South Fork Prosser Creek, a species that requires standing water for most of the growing season (Figure 4). Codominant species in the Wetland community at slightly higher elevations included *Juncus articus* (Baltic rush) and *Carex nebrascensis* (Nebraska sedge) (Figure 4).

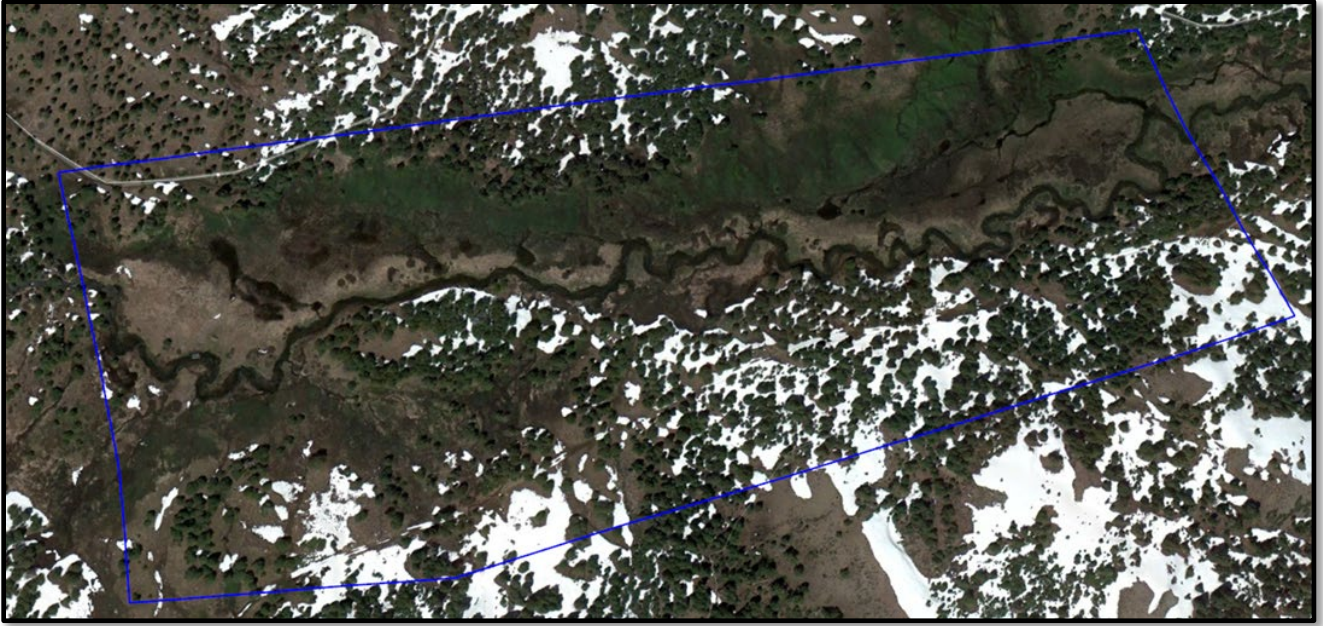
Figure 6: Euer Valley meadow June 2011 aerial image (Source: Google Earth). Note the surface water in the swales likely fed by springs while the immediate area along the creek does not appear to have any sustained saturation by an overbanking event.

The valley floor in the study area consists of a meadow floodplain. The meadow receives abundant hydrologic support from groundwater migration from the valley sides, although this appears to be primarily associated with the north side of the valley. This level of inflow is so substantial that there are a number of seeps and small spring-fed ponds that persist well into the growing season (Figure 5). This groundwater inflow provides for a remarkably high level of vigor in the meadow vegetation. Aerial photographs taken during the end of the snowmelt period show the “greening up” of the meadow while the immediate vicinity of the creek has not yet responded. This indicates that the primary

hydrologic support of the meadow is lateral subsurface inflows, as opposed to overbank flooding from the creek. However, aerial photographs taken later in the growing season, July, and August, does show uniform green conditions, even along the stream itself indicating that the condition of the stream is not adversely affecting the vigor of the meadow (Figures 6 and 7). In fact, groundwater migration toward the creek may indicate that the stream is a gaining reach within the study area, i.e., the meadow may be supporting the stream as opposed to the stream supporting the meadow.

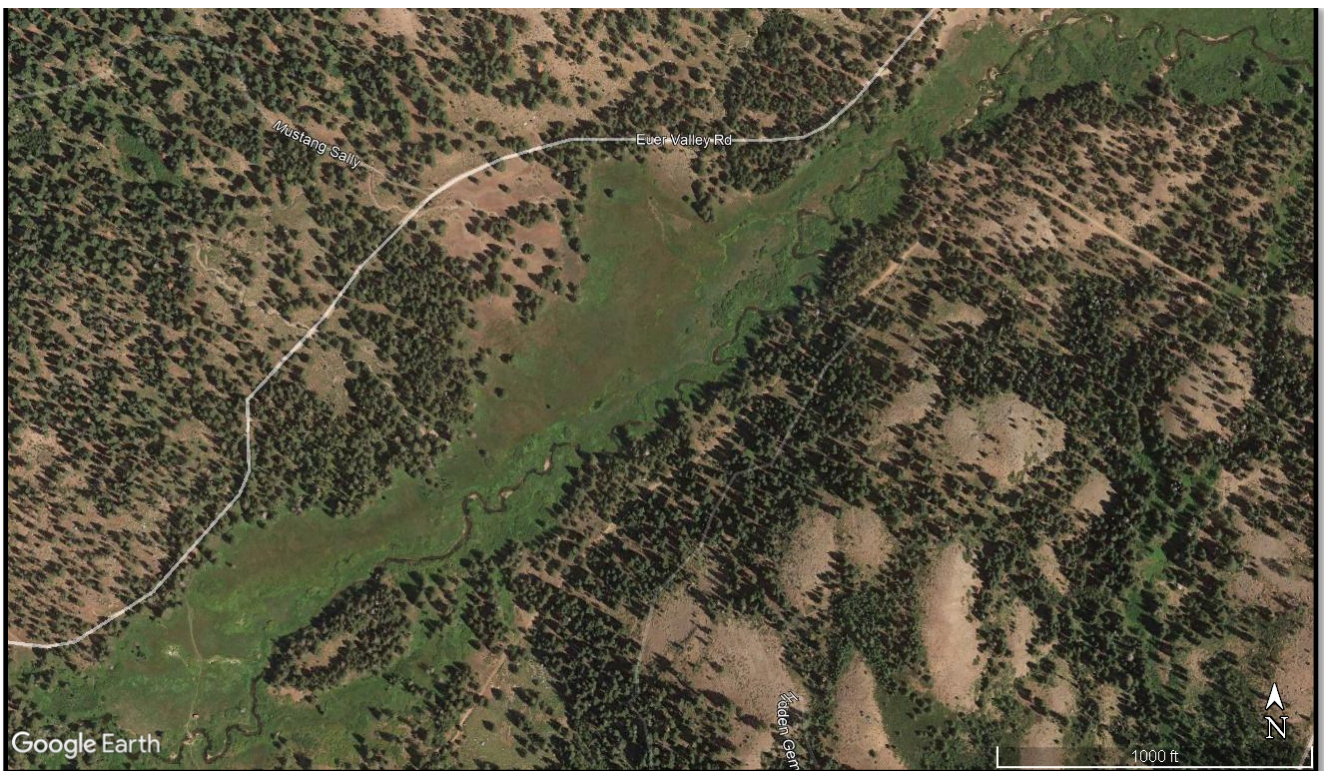
Figure 7. Euer Valley meadow August 11, 2017 showing growing green conditions throughout the meadow.

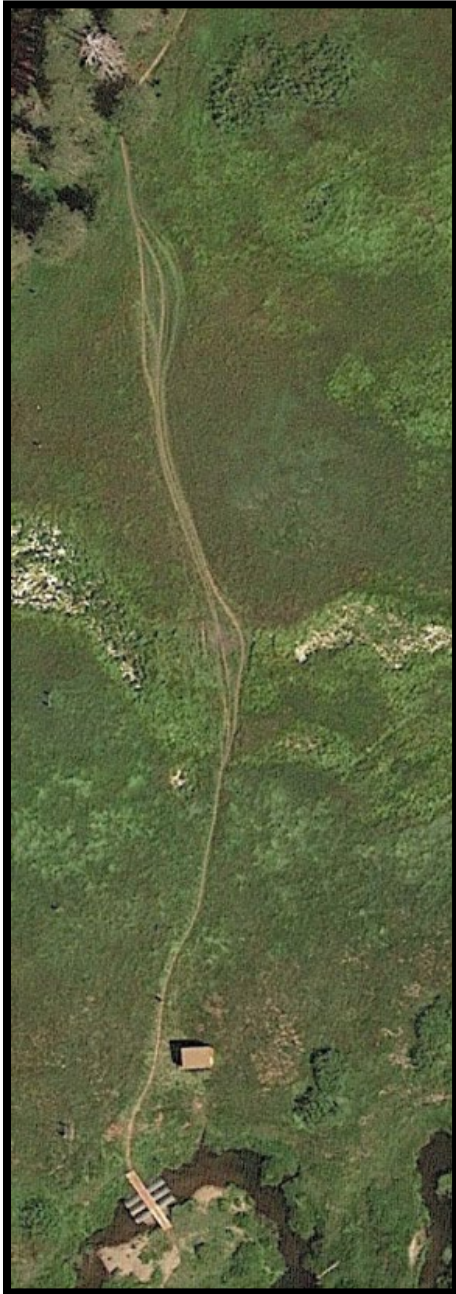
Figure 8. North side of Coyote Crossing Trail showing clear signs of braiding at locations of spring fed swales, August 2017 (Google Earth)

Due to the persistent standing water well into peak recreation months, multiple volunteer trails are formed (Figure 8). This is especially apparent where it crosses the spring fed swales as recreationists avoid getting their feet wet. This behavior likely exacerbates erosion in the saturated meadow area, compacts soil, and stunts vegetation growth within the vicinity of the existing trail alignment. Once a preferred trail alignment is selected the remaining redundant trails and trail segments under new boardwalks will be decommissioned by de-compacting (ripping/tilling) and revegetating. TDA has indicated disturbance by equestrians is especially concerning and would like to discourage equestrians from fording the river at locations other than a developed crossing. Coyote Crossing is a key part of TDA's existing trail system because it is the only crossing on the South Fork Prosser Creek until the access road, Alder Creek Road over 2 miles to the East. There is a warming hut, i.e., Coyote Hut, just northwest of Coyote Crossing that is primarily used by cross-country skiers in the winter season.

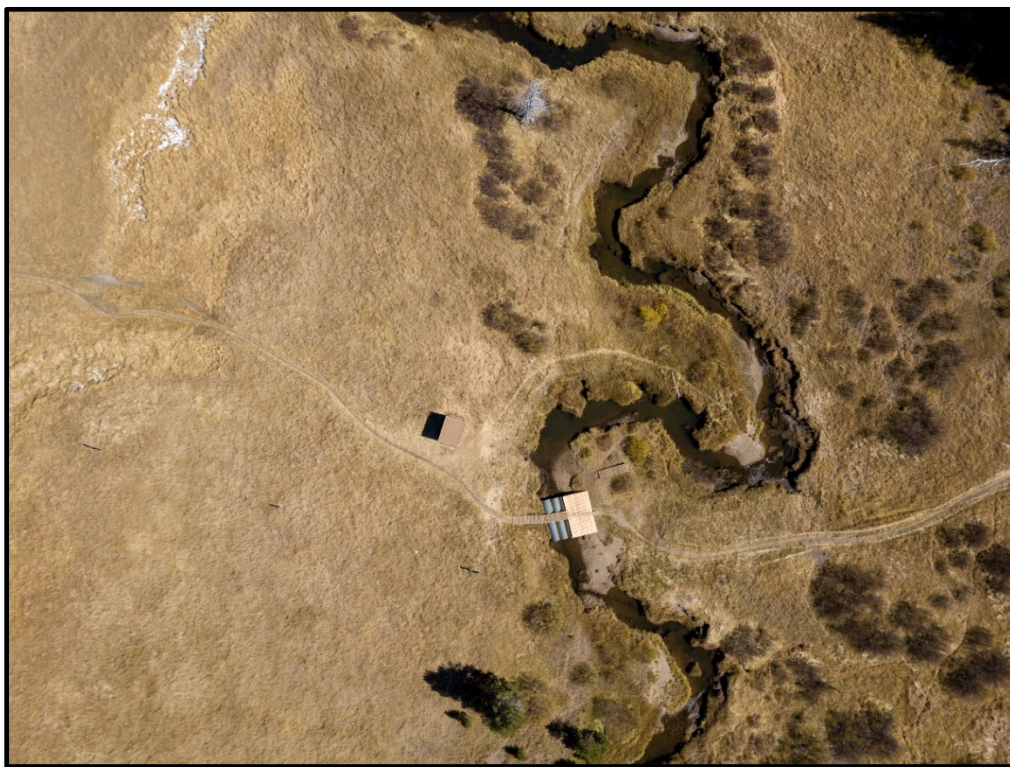
Figure 11. View of existing culverted crossing (Coyote Crossing). (Source: TDA Drone Footage)

The existing creek crossing (Coyote Crossing) consists of 3 CMP culverts covered by an anchored wooden walkway and a constructed access ramp which allows summer and winter recreationists and groomers to cross (Figure 11). As a result of the spring fed swales, the north trail approach to the culverted crossing remains saturated with persistent standing water often into July making access difficult and detrimental to the wetland surface.

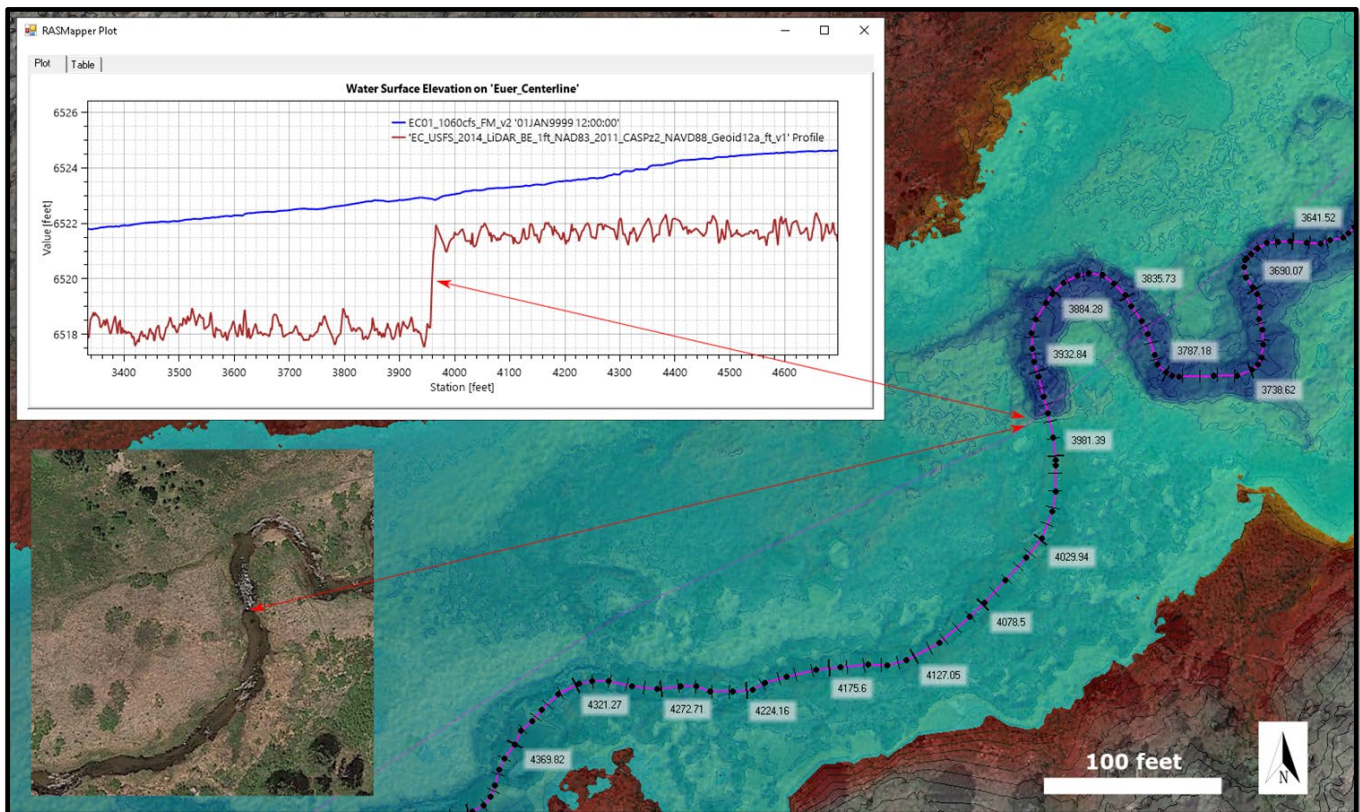
Figure 13. Location where relic beaver dam held grade and resulted in 4 feet of drop (Source NHC 2020)

Based on the geomorphic data however, the relic beaver dam appears to have significantly held the channel grade and contributed to aggradation upstream (Figure 13). In order to mitigate any potential future incision from migrating upstream of this location given the beaver dam is no longer active, we recommend a series of boulder cascade weirs to hold channel grade while stepping down from the higher elevation reach above the location of the former beaver dam to the reach below. In addition, engineered log and root wad structures can be incorporated at strategic locations to increase and improve in-channel aquatic habitat complexity.
