DECISION PAPER

Issue: Snowbird Chairlift Replacement

INFORMATION

Snowbird Chairlift replacement and Learning Center improvements at Tahoe Donner Downhill Ski Area

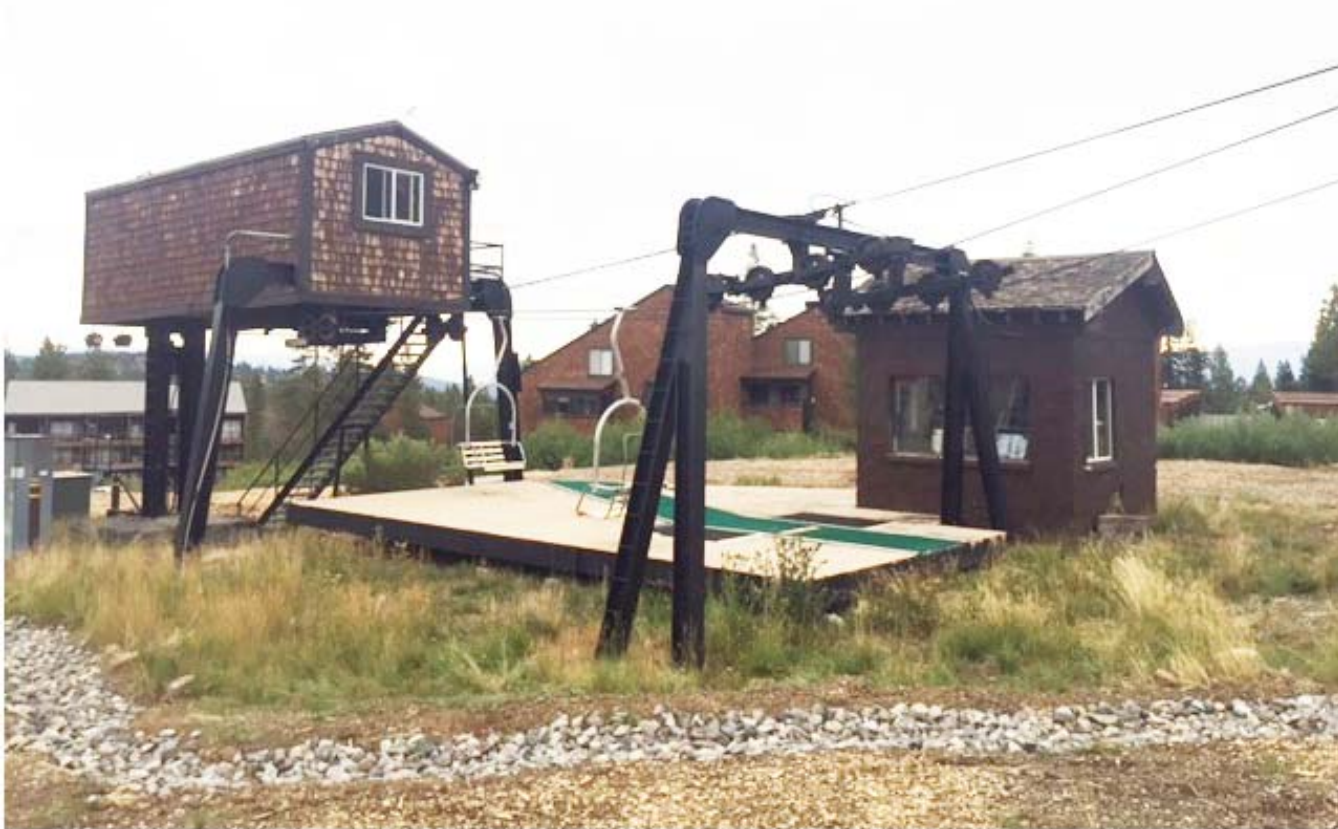
Current Snowbird Chairlift c.1971

- The existing Snowbird Chairlift currently meets all annual inspections, but is nearing the end of its useful life and exceeds the average age of lifts in the U.S.
- **SLI**, the original manufacturer of the Snowbird Chairlift, is no longer in business, making replacement parts and trained service technicians difficult to source.
- Bottom and Top Terminals currently constrain skiable terrain and reduce circulation.
- Forthcoming code changes require new tower head platforms for maintenance access.
- Old sheave design requires regular tower access and maintenance during storms.
- Additional mechanical breakdowns could impact service levels and reduce revenues.

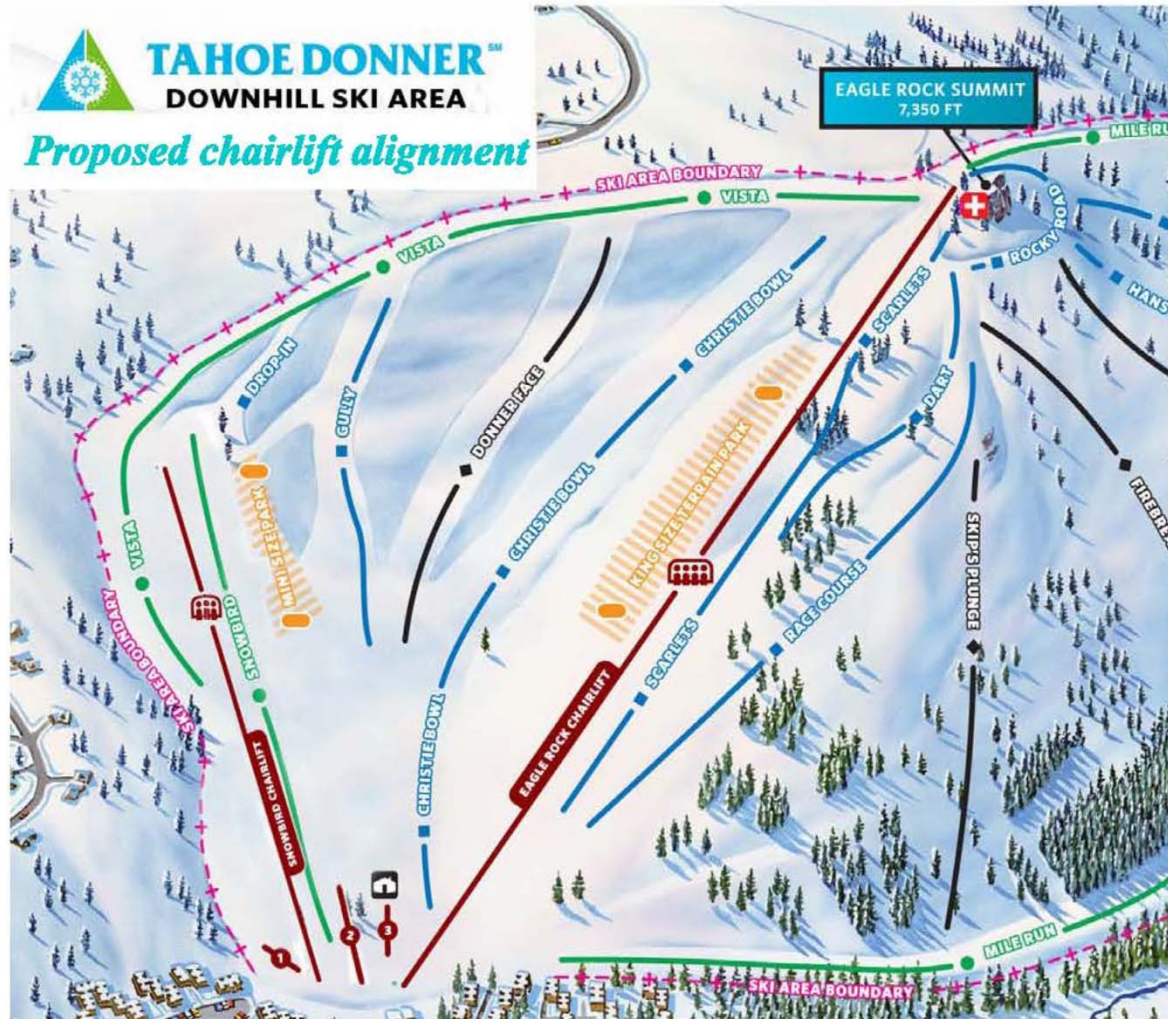
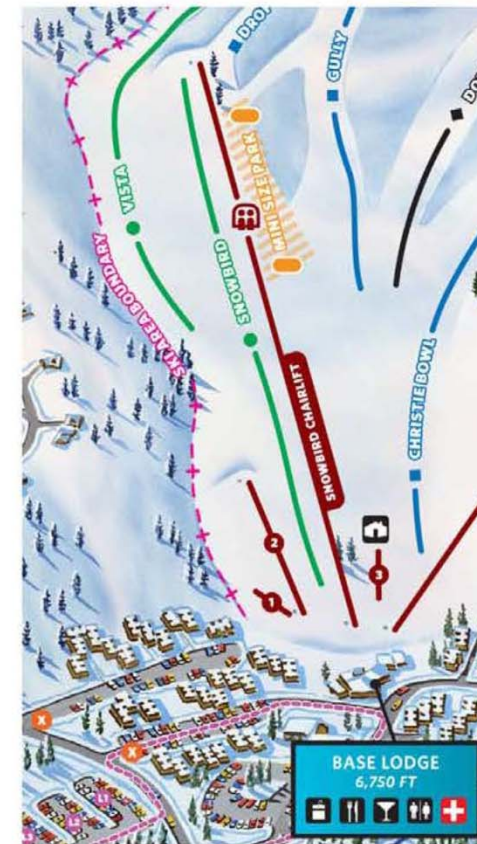
Proposed chairlift alignment

Existing chairlift alignment

- Would moving Snowbird Chairlift improve the skier experience? **By moving the Chairlift east by approximately 100', the lift towers would no longer be in the middle of the ski run. And although access to the lift line is approximately 70 more feet on level terrain, Conveyor 2 could provide efficient access. When unloading the chair at the top terminal, this orientation provides about three times more space to safely exit and orient downhill.**

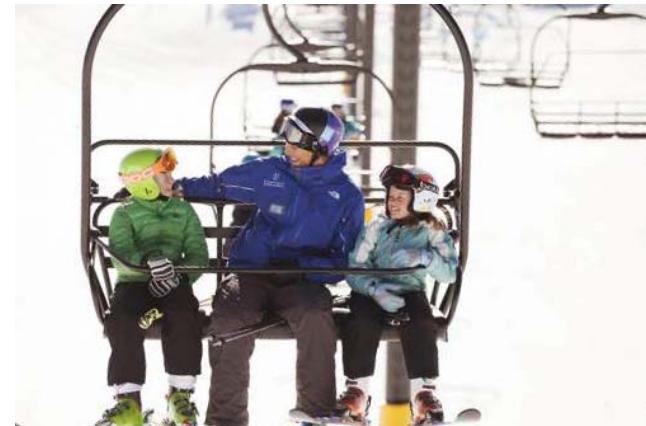
Example of a Gallery cover that could be installed at existing conveyors to enhance learning experience and reduce opening time after winter storms.

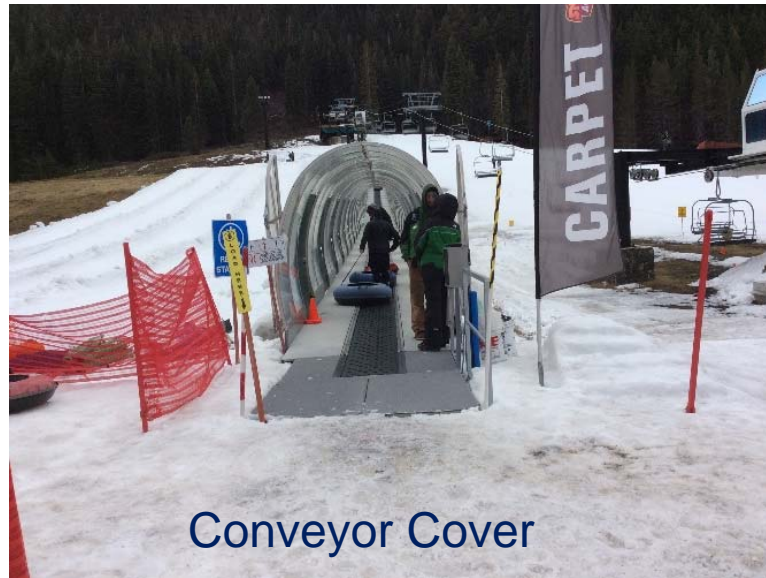
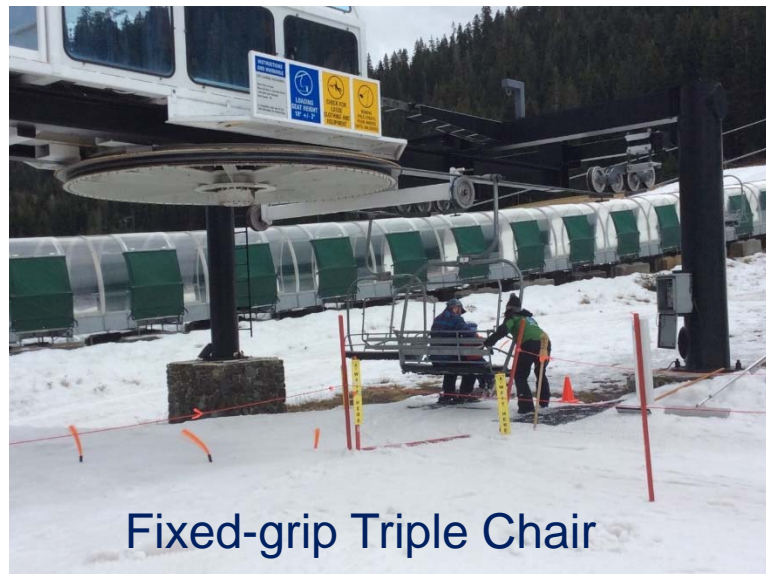
“Kid Stops” U-Block System from Leitner-Poma of America also available.

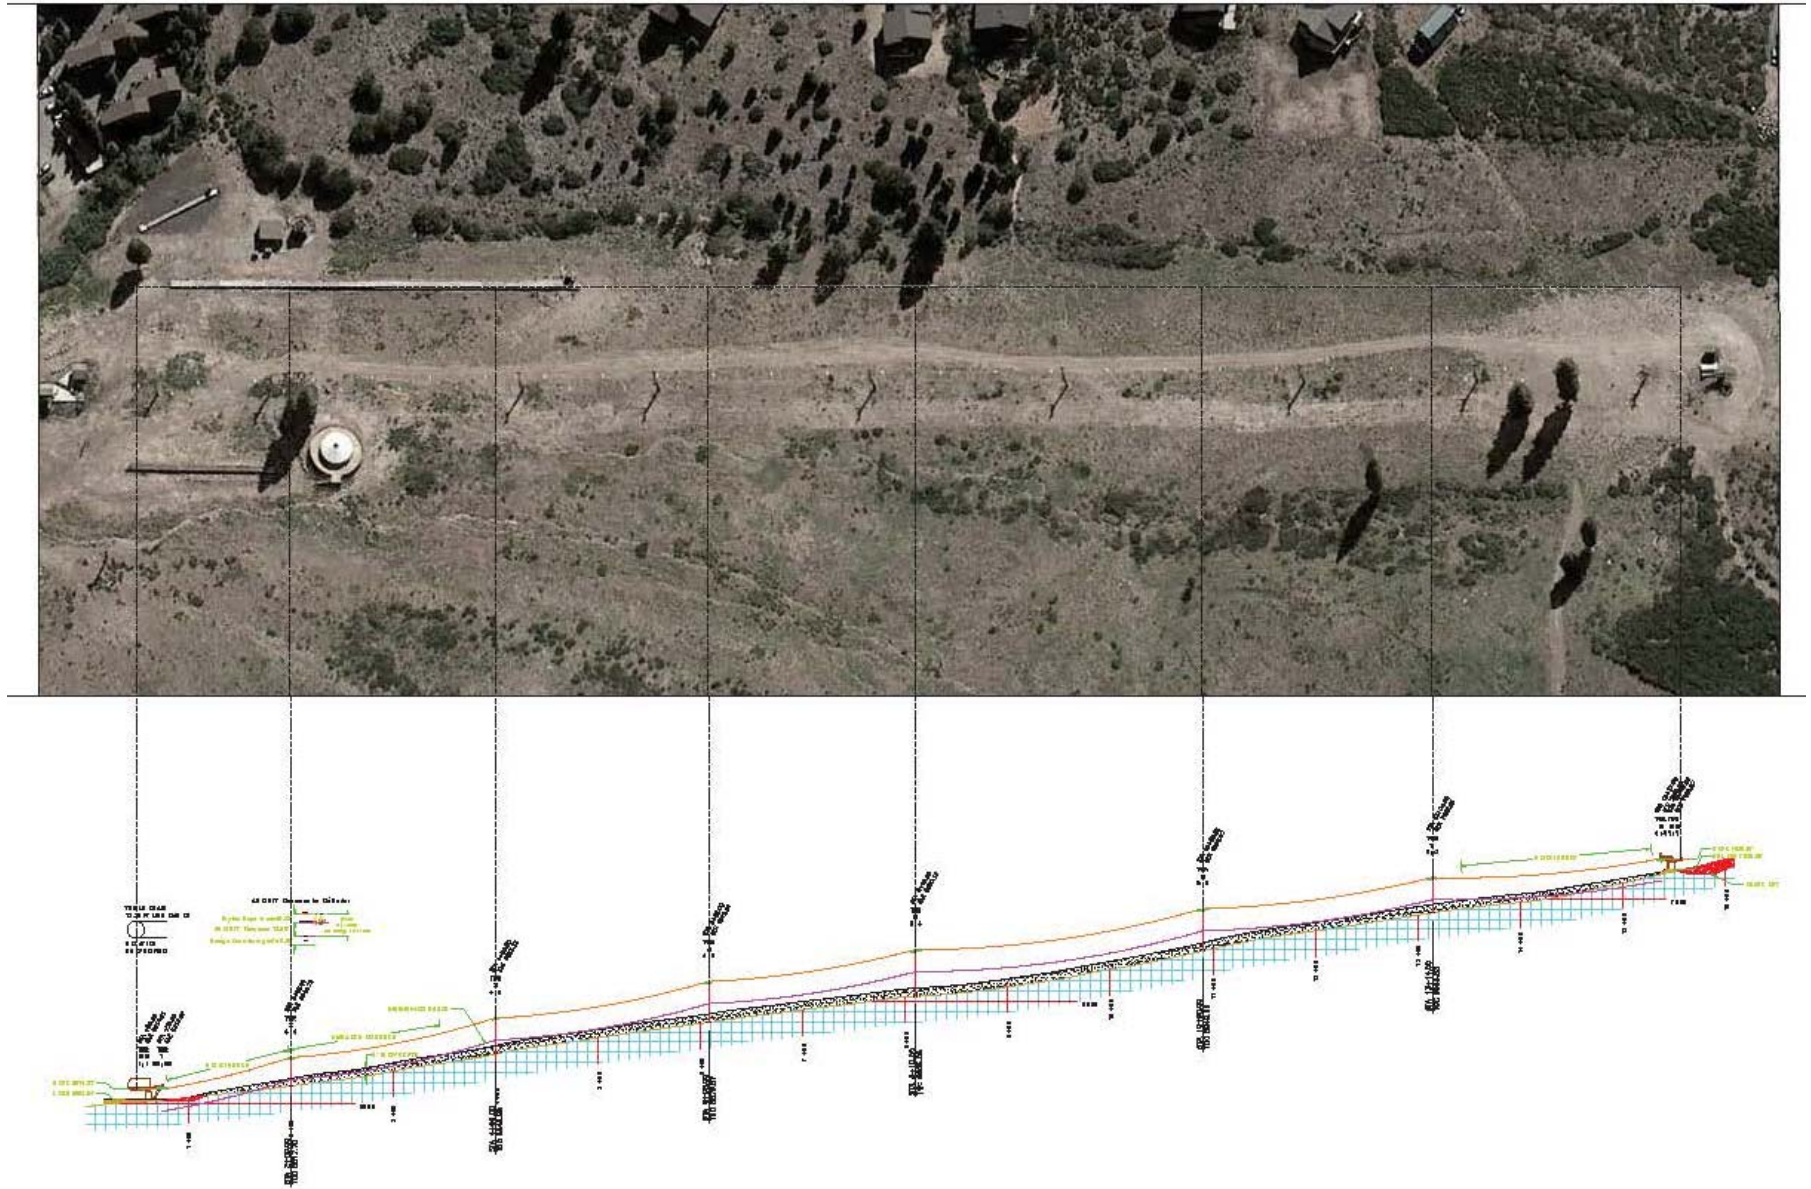
Initial Engineering Analysis and Tower locations

Six proposed towers versus nine existing

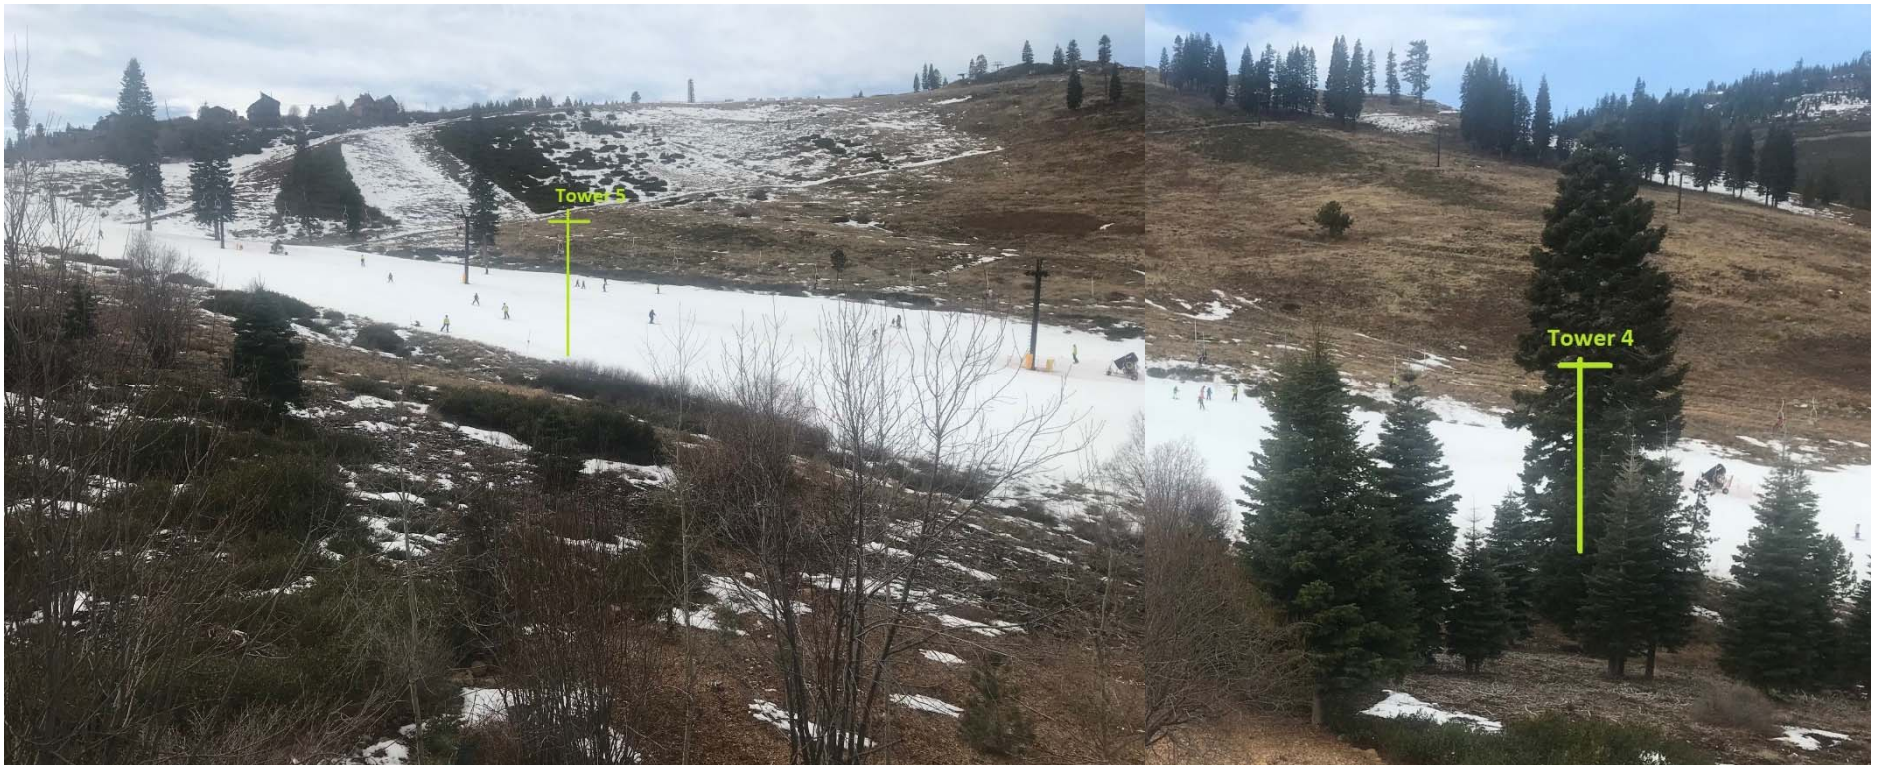
Initial Engineering Analysis and Tower locations

- Proposed Tower's 4 and 5 shown at edge of Snowbird Run
- Green is for discussion purposes only, Towers will be painted black
- Towers will be +/- 30' tall, similar to Eagle Rock
- Existing trees help filter views of Tower 4 from adjacent homes.
