Issue: Snowbird Chairlift Replacement

Purpose: Board update regarding the proposed Snowbird Lift replacement at TDA's Downhill Ski Resort.

Snowbird Chairlift replacement and Learning Center improvements at Tahoe Donner Downhill Ski Area

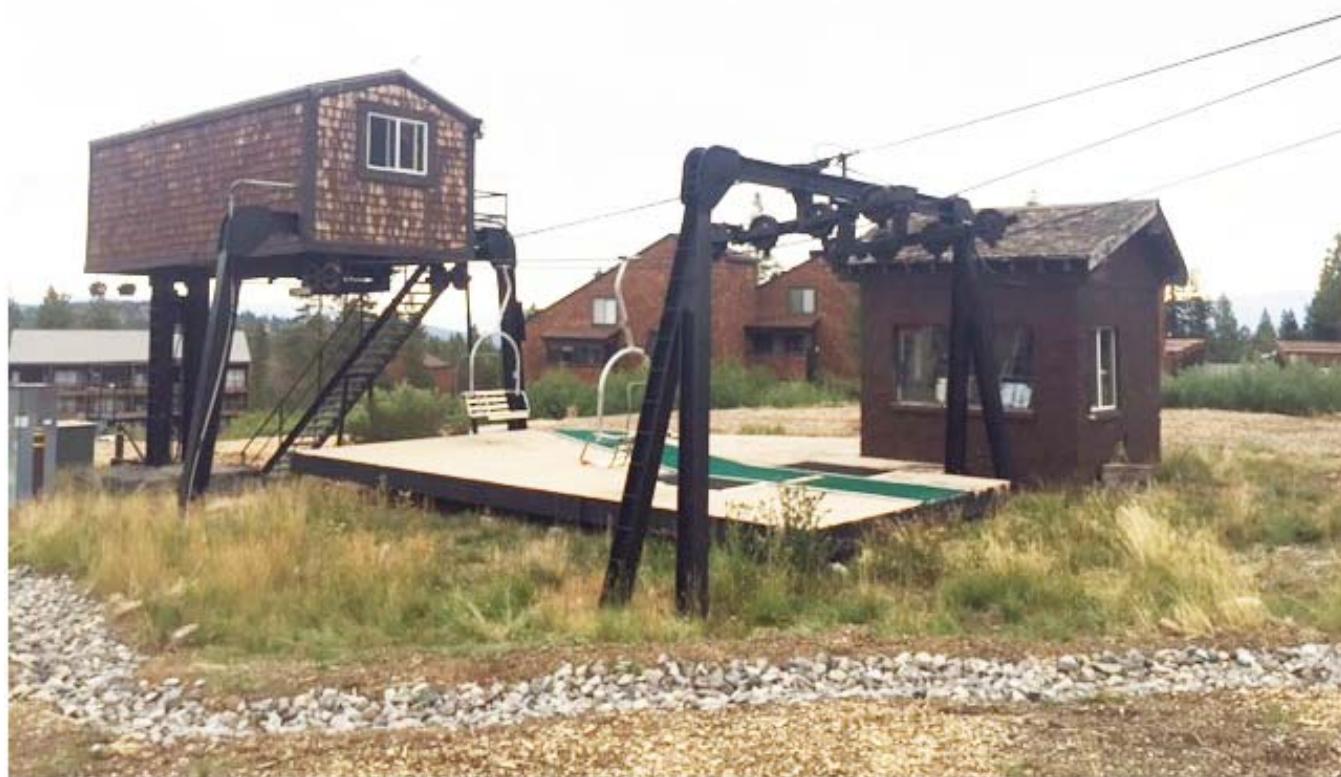
Current Snowbird Chairlift

c.1971

- The existing Snowbird Chairlift currently meets all annual inspections, but is nearing the end of its useful life and exceeds the average age of lifts in the U.S.
- SLI, the original manufacturer of the Snowbird Chairlift, is no longer in business, making replacement parts and trained service technicians difficult to source.
- Bottom and Top Terminals currently constrain skiable terrain and reduce circulation.
- Forthcoming code changes require new tower head platforms for maintenance access.
- Old sheave design requires regular tower access and maintenance during storms.
- Additional mechanical breakdowns could impact service levels and reduce revenues.

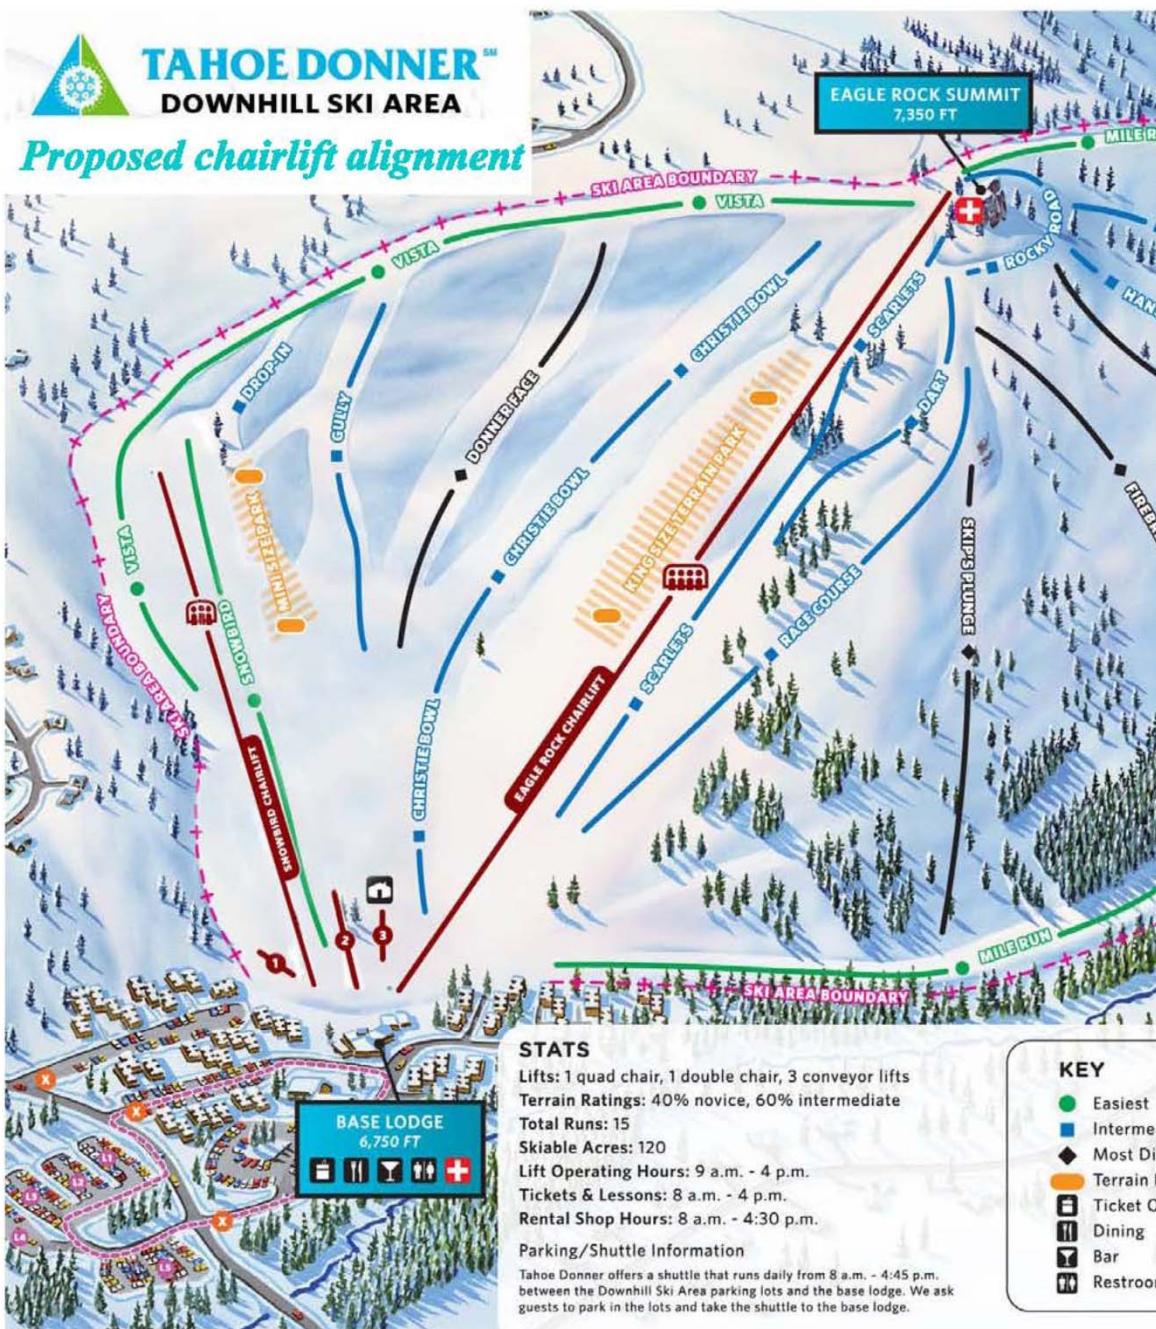
Proposed chairlift alignment

- The new Chairlift could be placed in the existing alignment, although opportunities for an improved Learning Center are as follows:
 - The new Chairlift could trade places with Conveyor 2 (C2), which could be reduced in length to provide consistent learning terrain as well as access the existing Yurt.
 - Gallery covers could be installed to improve learning experience and reduce opening time after winter storms.
 - Resulting space may allow for improved Terrain Based Learning.

- Would moving Snowbird Chairlift improve the skier experience? By moving the Chairlift east by approximately 100', the lift towers would no longer in the middle of the ski run. And although access to the lift line is approximately 70 more feet on level terrain, Conveyor 2 could provide efficient access. When unloading the chair at the top terminal, this orientation provides about three times more space to safely exit and orient downhill.

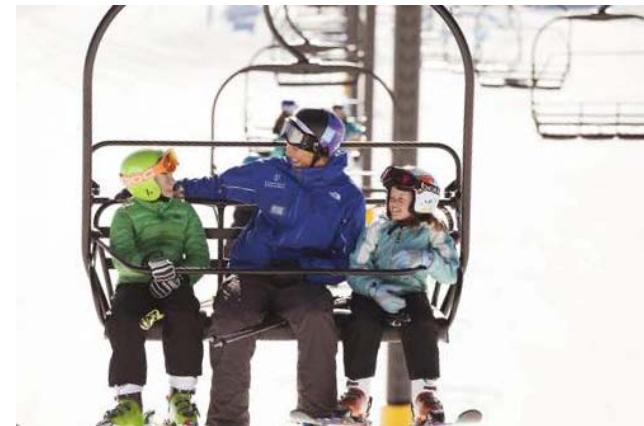
Example of a Gallery cover that could be installed at existing conveyors to enhance learning experience and reduce opening time after winter storms.

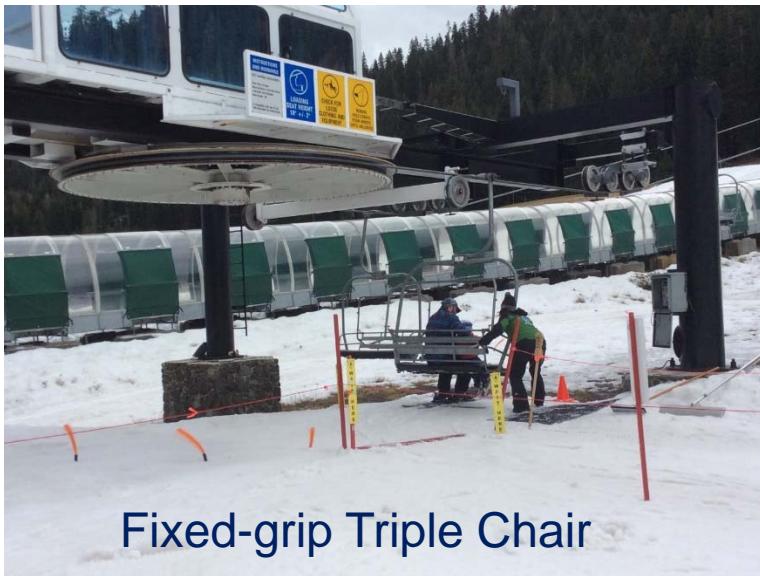
Fixed-grip Triple Chair

“Kid Stops” U-Block System from Leitner-Poma of America also available.

- Ski-school instructors can efficiently manage one student on either side during loading and unload.
- A lighter chair has less swing speed during skier unload, which eliminates the need for a steeper exit ramp (similar to top of Eagle Rock), providing a safer and superior learning experience for beginner skiers.
- Easier for maintenance and lift operations due to the reduced mass of the chair.
- A triple-chair can move just as many guests per hour as a quad-chair, because quad chairs have slightly greater spacing on the cable to keep total skier weight the same and within engineering specifications.

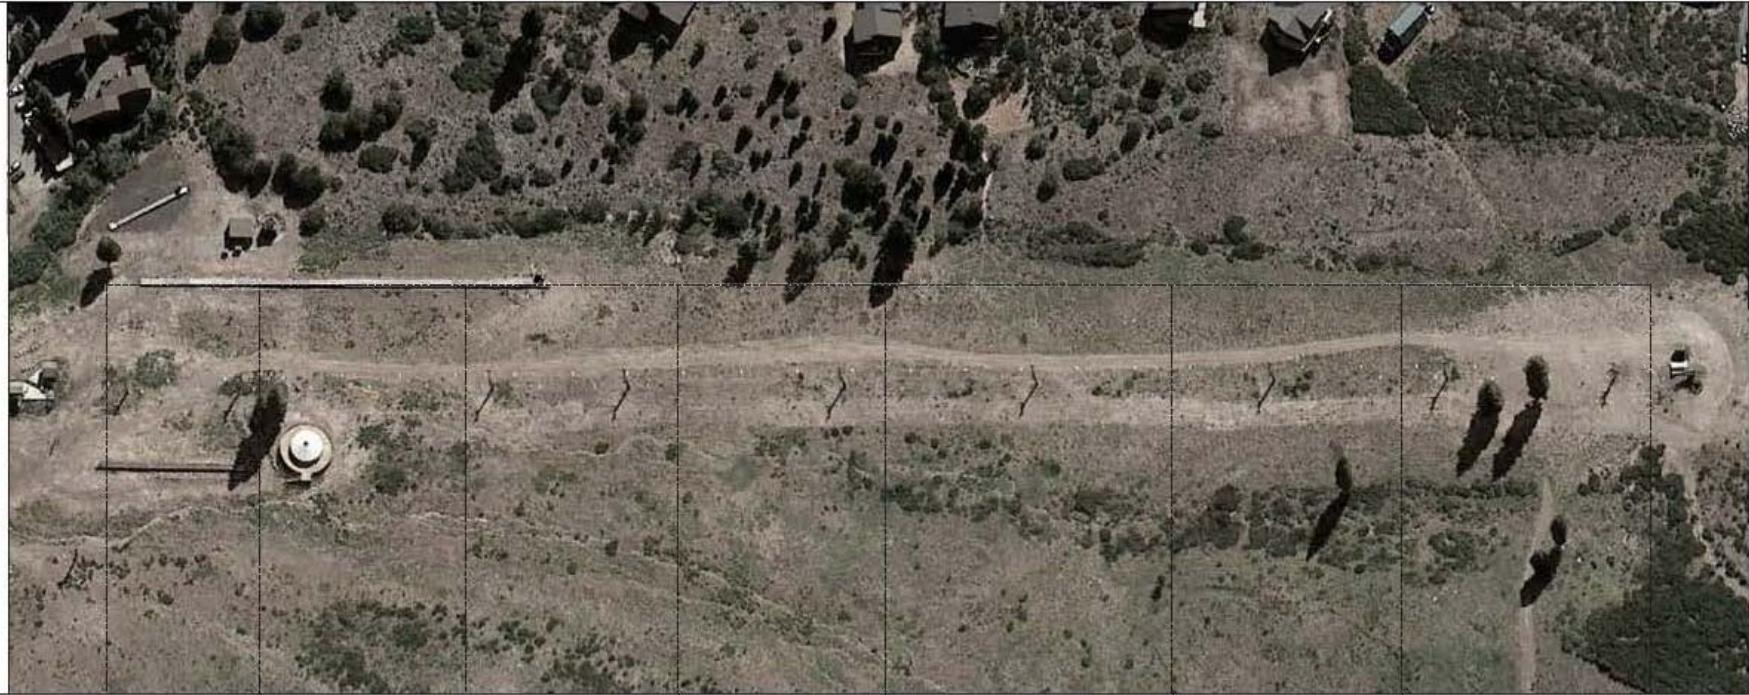
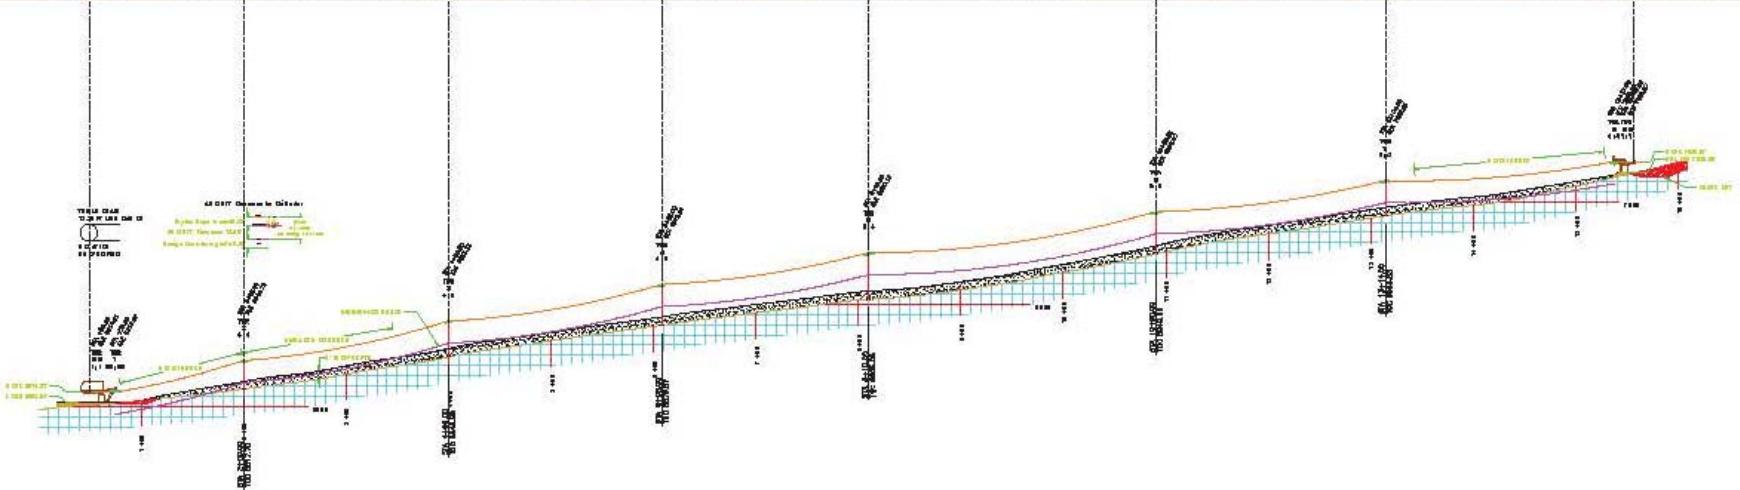
Six proposed towers versus nine existing

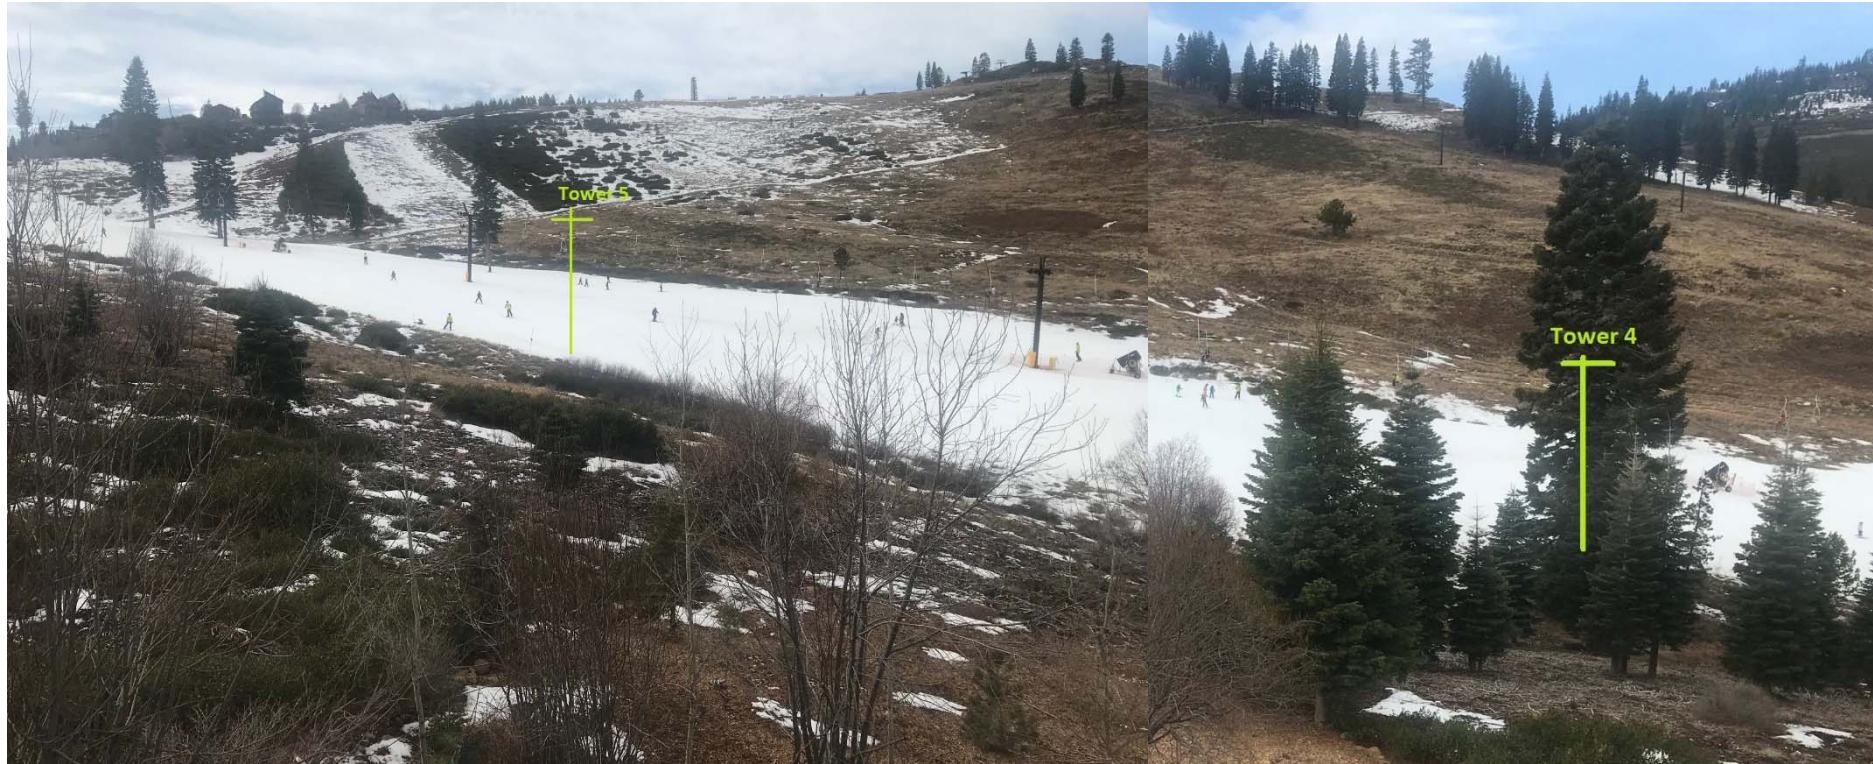
Initial Engineering Analysis and Tower locations

- Proposed Tower's 4 and 5 shown at edge of Snowbird Run
- Green is for discussion purposes only, Towers will be painted black
- Towers will be +/- 30' tall, similar to Eagle Rock
- Existing trees help filter views of Tower 4 from adjacent homes.
